Geological mapping of slope at entrance of Adit NO.3

PROJECT TITLE  
Upper Trishuli-1 HEP (216MW)

DRAWING TITLE  
Geological map of slope at entrance of ADIT NO.3

INDEX	DRAWING NUMBER	SHEET NO.	REV. NO.
A	UT1-C-855-G-AD-3-01	1 OF 1	0

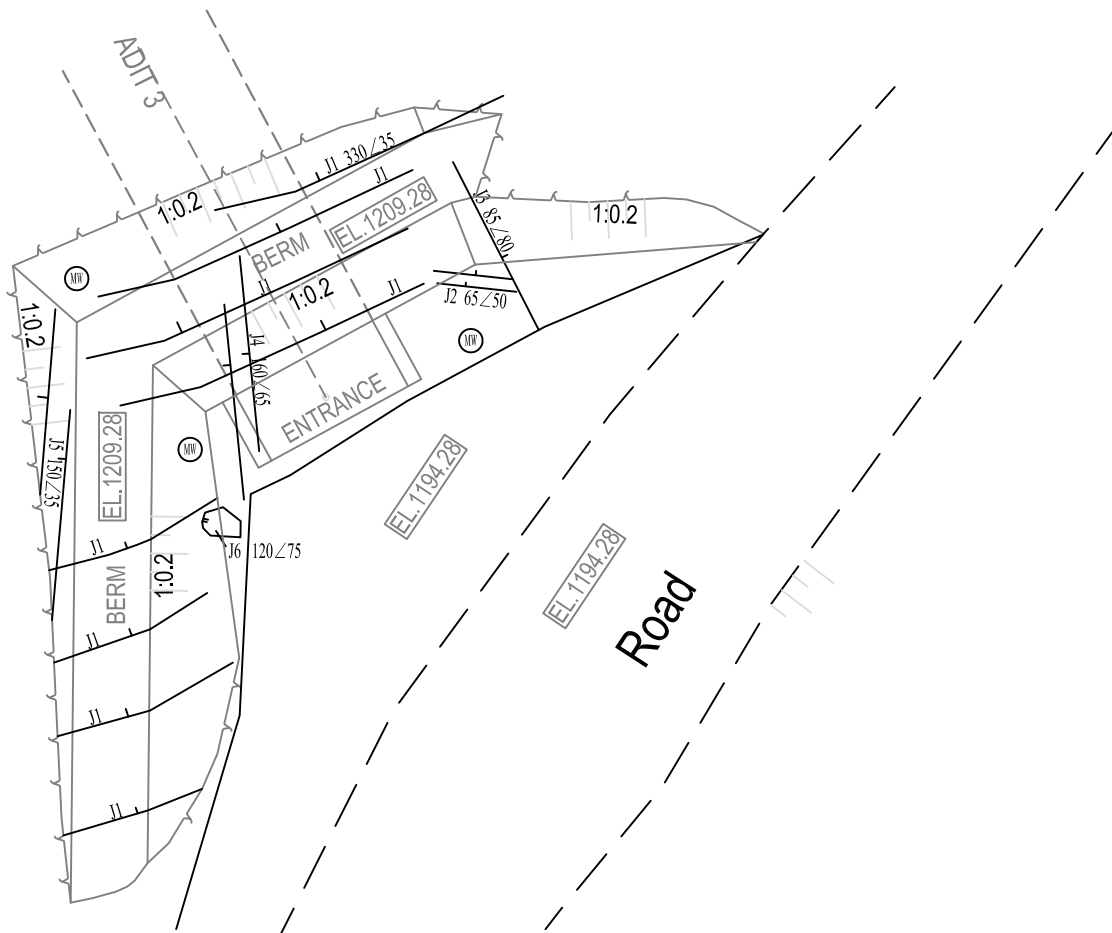
Slope Elevation	EL. 1194. 28-EL. 1209. 28
Rock types	Mi+Qu Sch
Rock hardness	Medium hard rock
Degree of weathered	Moderately weathered
Rock attitude (Dip direction/dip)	330° ∠35°
Rock mass classification	III
Groundwater situation	The slope surface is dry

STAKE	TUNNEL	ROCTYPEK	UCS	GROUND WATER	RQD	Jv	Jn	Jr	Ja	Jw	SRF	$Q=\frac{RQD\times J_r\times J_w}{J_n\times J_a\times SRF}$	ROCKMASS CLASS	DATE	
	DIRECTION	Mi+Qu Sch		GW1	70	13.6	6	4	3	1	2.5	6.2	III	2022.1.16	
NO.	Occurrence		SEPARATION (m)	JOINTS GROUP		PERSISTENCE	ROUGHNESS/ APPEARANCE	FILLING	WEATHER OF ROCK WALL	FAULT		UCS			
	Dip direction	Dip angle		SPACING	NUMBER					INFLUENCEDZONE (m)	NATURE	Very high		>250	
												High		100-250	
												medim high		50-100	
J1	330	35	C1	SP3	20	C3	R2	F4	W3			moderate		25-50	
J2	65	50	C1	SP2	5	C3	R2	F13	W3			Low		5-25	
J3	85	80	C3	SP1	3	C3	R2	F13	W3			Very low		1-5	
J4	160	65	C2	SP2	5	C3	R2	F3	W3			RQD%			
J5	150	35	C2	SP1	2	C3	R2	F13	W3			Excellent quality		90-100%	
J6(Plane)	120	75	C0			C2	R4					Good quality		75-90%	
	SEPARATION(APERATURE)		SPACING OF JOINTS		PERSISTENCE		ROUGHNESS/APPEARANCE		FILLING			Fair quality			50-75%
	C0:Very tight <0.1mm		SP1:VERY WIDE >2m		C1:Very Low <1m		R1:very rough surfaces		F1:rock sillar		F8: Breccia		Poor quality		25-50%
